## GE 23 TON SWITCH ENGINE

### HISTORY

This switch engine was built in 1941 by General Electric. It passed through many hands, and ended up at a refinery near San Francisco Bay.

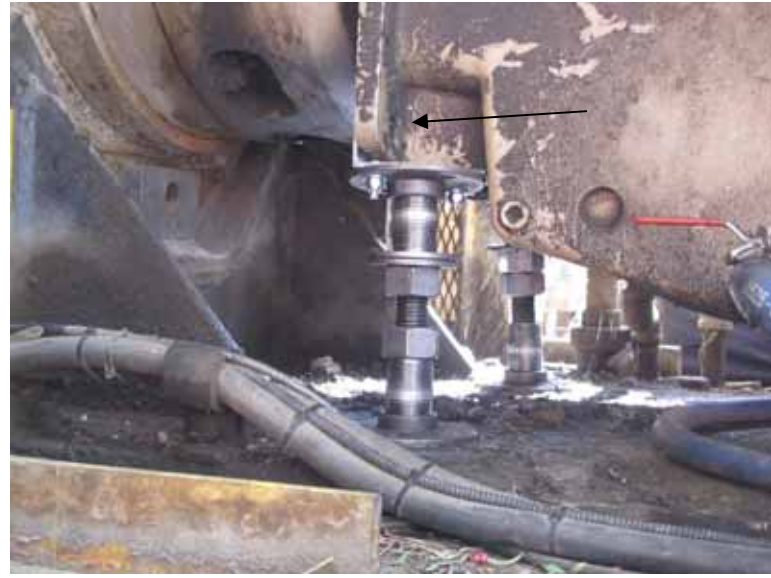
What we did was all well and good, but we had to face the biggest problem which was the cracked bell housing. Our analysis of the problem was that the diesel engine was supported at the front, but relied on the bell housing to provide support for the rear of the engine. The bell housing was cast iron,

and was not designed to handle that kind of stress, and eventually cracked on both sides, rendering the engine inoperable.

We designed an adjustable support for the rear of the engine, and installed it temporarily for a fit check. The results were very encouraging, as the cracks in the bell housing closed up!

We also found a 9/16 inch hole in the back of the engine (arrow) to which we can bolt the brackets. We put a wrench on the back of the generator, and we were able to turn the engine. It did take a bit of effort, but we realized we were not only turning the engine crankshaft, but also the generator rotor!

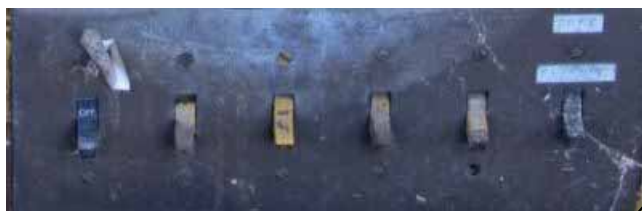
## SWITCH PANEL

In anticipation of getting the engine running, we researched the original wiring diagram, which bears some resemblance to the way the engine is wired now. There is a series of toggle switches on the panel that are unmarked. In looking at the panel of a similar engine, we have figured out what the switch functions are. The first effort was to locate the Control Switch, which supplies power to the relays controlling the direction of the engine.

GE 2228S DPST SWITCH

10 AMP  
FUSES
