## GE 23 TON SWITCH ENGINE

### HISTORY

### BELL HOUSING REPAIR

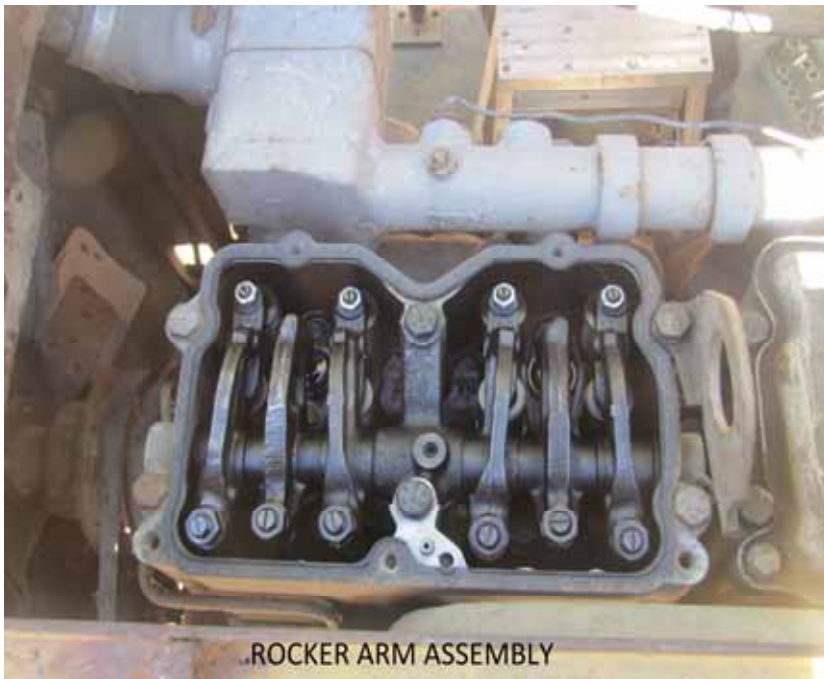
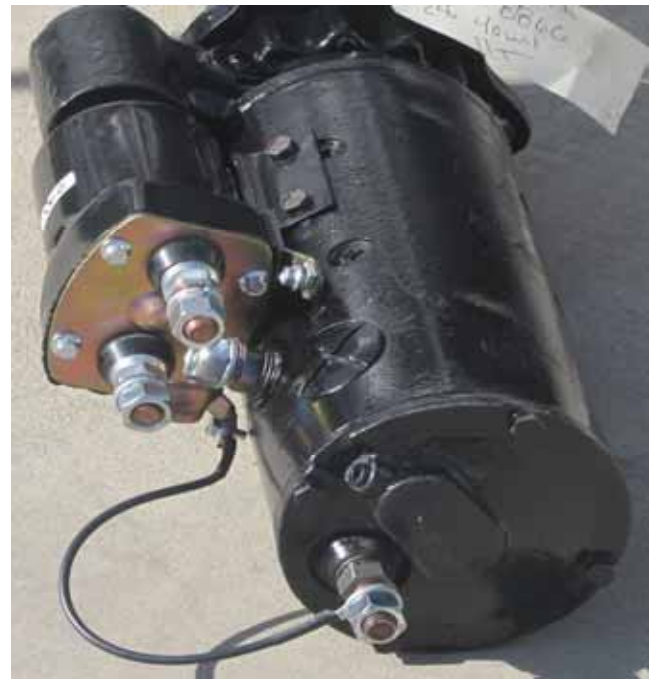
#### OVERHAULED STARTER

We removed the injectors and sent them to be cleaned and adjusted. We also poured some oil and transmission fluid into the cylinders to help loosen them. We also removed the starter and had it overhauled

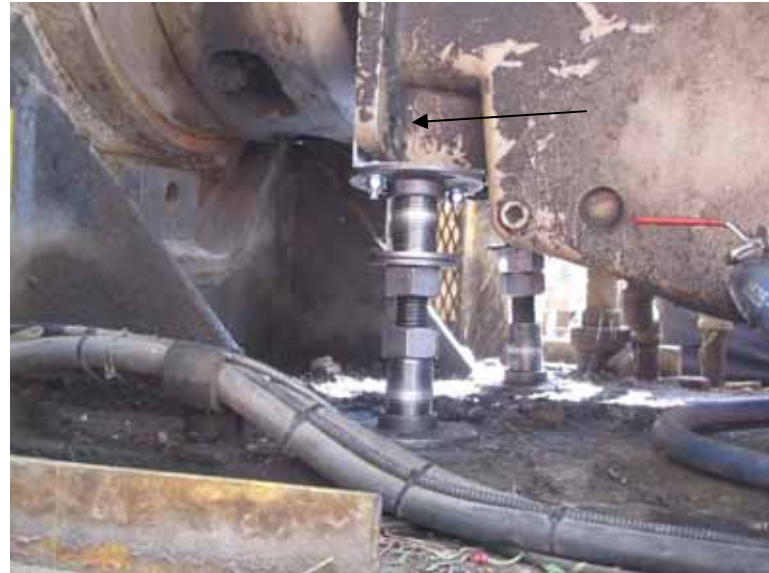
What we did was all well and good, but we had to face the biggest problem which was the cracked bell housing. Our analysis of the problem was that the diesel engine was supported at the front, but relied on the bell housing to provide support for the rear of the engine. The bell housing was cast iron,

and was not designed to handle that kind of stress, and eventually cracked on both sides, rendering the engine inoperable.

We also found a 9/16 inch hole in the back of the engine (arrow) to which we can bolt the brackets. We put a wrench on the back of the generator, and we were able to turn the engine. It did take a bit of effort, but we realized we were not only turning the engine crankshaft, but also the generator rotor!

We designed an adjustable support for the rear of the engine, and installed it temporarily for a fit check. The results were very encouraging, as the cracks in the bell housing closed up!

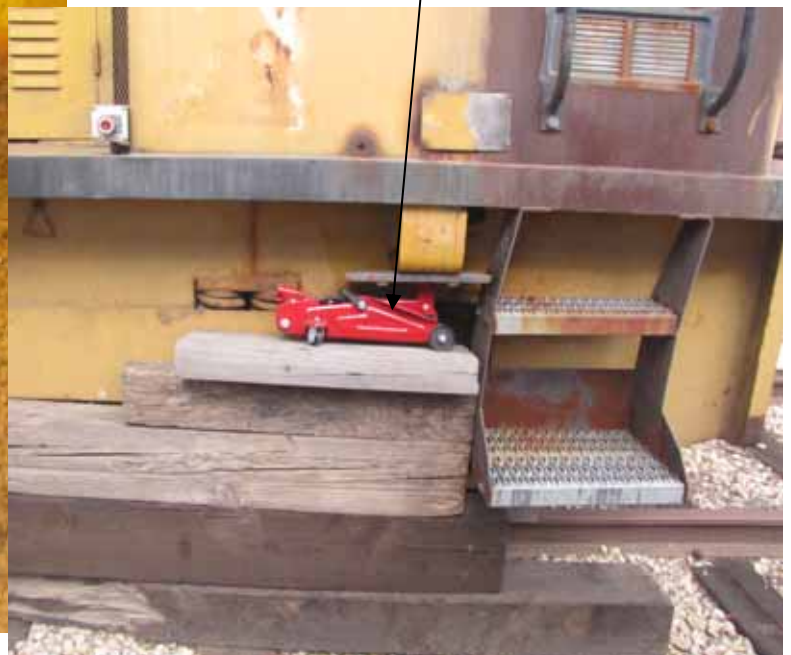
#### JACK

In the meantime, we attended to another problem brought on by the inactivity of the engine and the close proximity to San Francisco Bay. The hand brake next to the battery box was frozen with rust. We moved the pawl and wire brushed the area around the gear. We then built a dam around the gear with plumber's putty and filled it with penetrating oil. We wire brushed the underside of the shaft and the plate holding the end of the shaft. We also applied penetrating oil at both places. Our plan is to let it soak for a while then try to move the hand brake. We will also try jacking the shaft from the bottom to break it loose. If all else fails, we may have to use a torch.

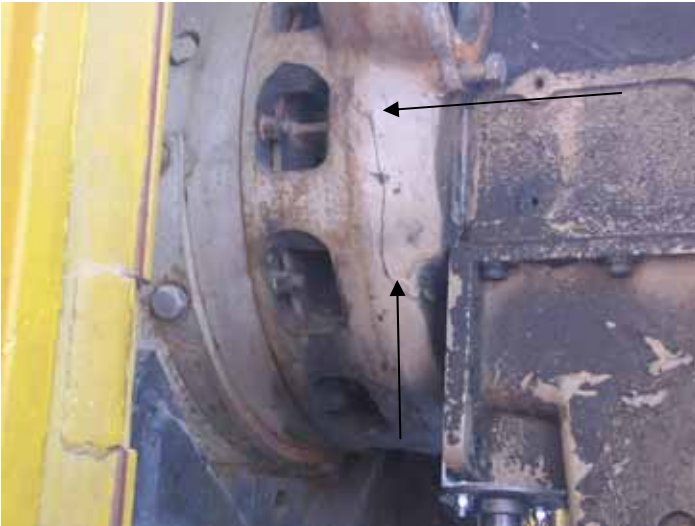
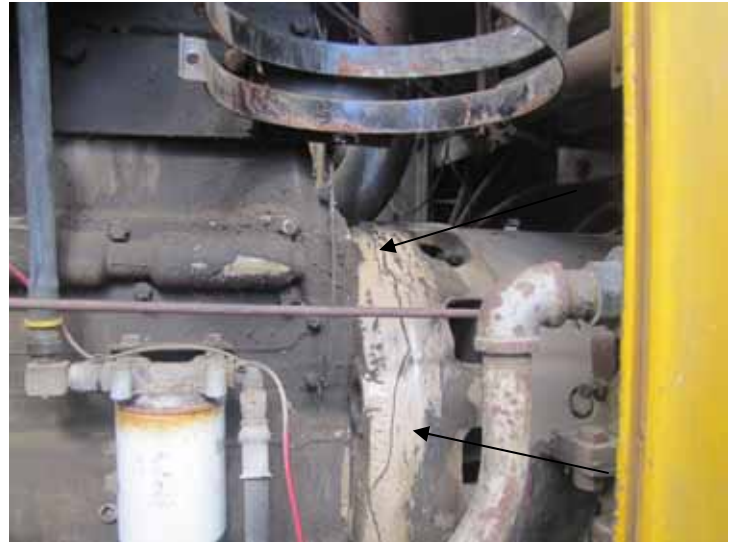
We sent the photos of the bell housing to Lock n Stitch to get a quote on them coming here and making a permanent fix. I received a response from Lock n Stitch requesting the length of the cracks and the material thickness. We made the measurements, sent the data to them.

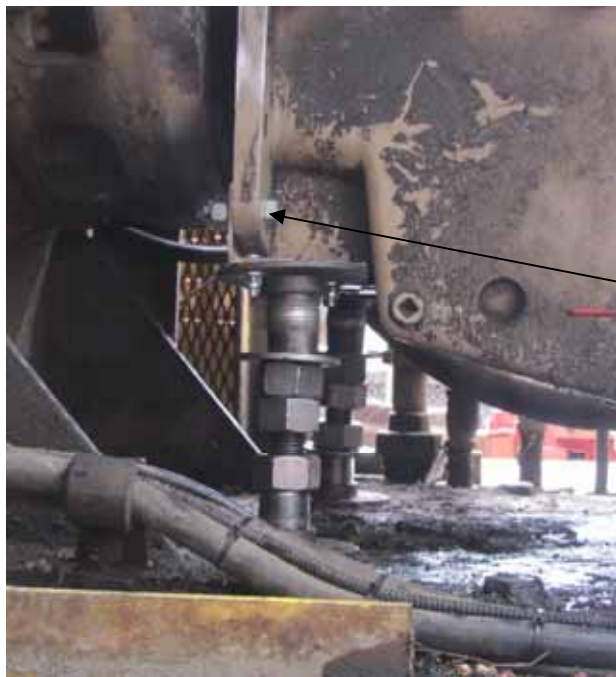
Right side  
through bolt

However, before we do anything we have to secure the rear engine mounts. We will match drill 9/16 holes in the brackets to line up with the holes on the back of the engine. We will then bolt the brackets to the rear of the engine with 9/16 bolts, lock washers, and nuts for a permanent installation

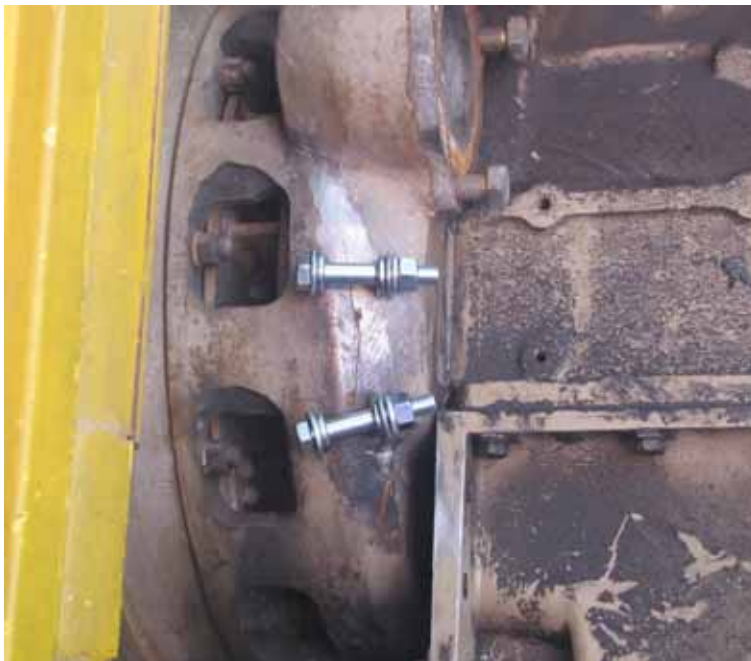
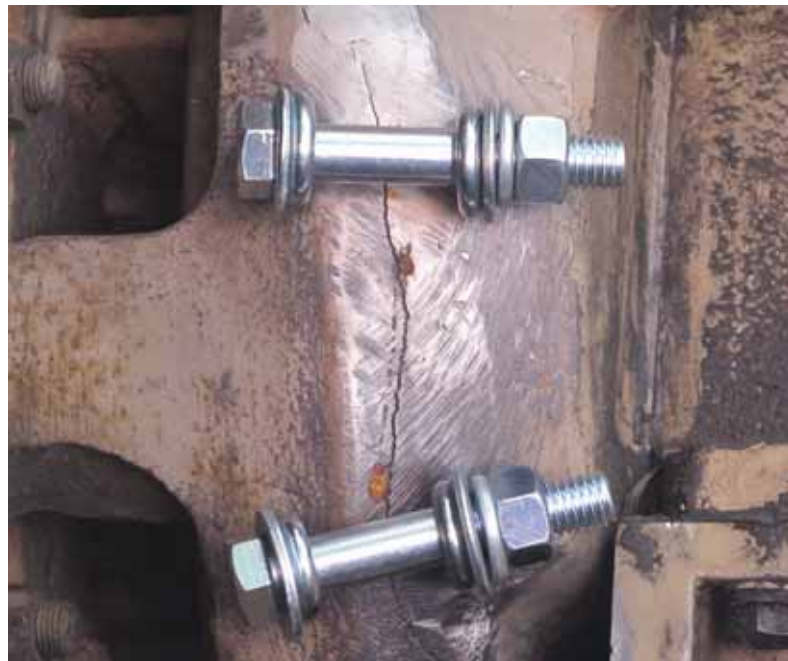
It turned out that the most difficult part was drilling through 3/4 of an inch of cast iron. The actual tapping of the holes was far easier, even using the technique suggested. I believe since the taps were new, they were sharper.

1. Drill and tap 1/4-20 holes on both sides of the cracks in the bell housing.
2. Install 1/4-20 threaded screw eyes in the holes.
3. Put a 1/2 inch bolt with washers, lock washer, and nut through the screw eye pairs
4. Tighten the bolts to secure the cracks closed.

We plan to start on the right side, as the crack is smaller. Because of the thickness of the bell housing, we will have to use plug in electric drills rather than cordless. We downloaded advice on how to drill and tap the cast iron bell housing, and will use plenty of cutting oil both on the drill and the tap. The drilling should go fairly quickly, but tapping the holes will take a lot more time. According to the article I downloaded, we will have to back the tap out frequently to clear the chips.

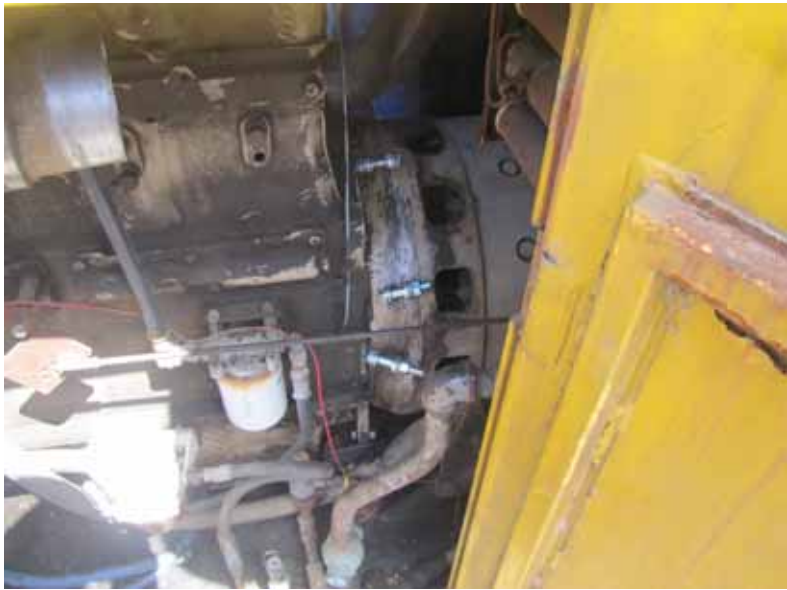
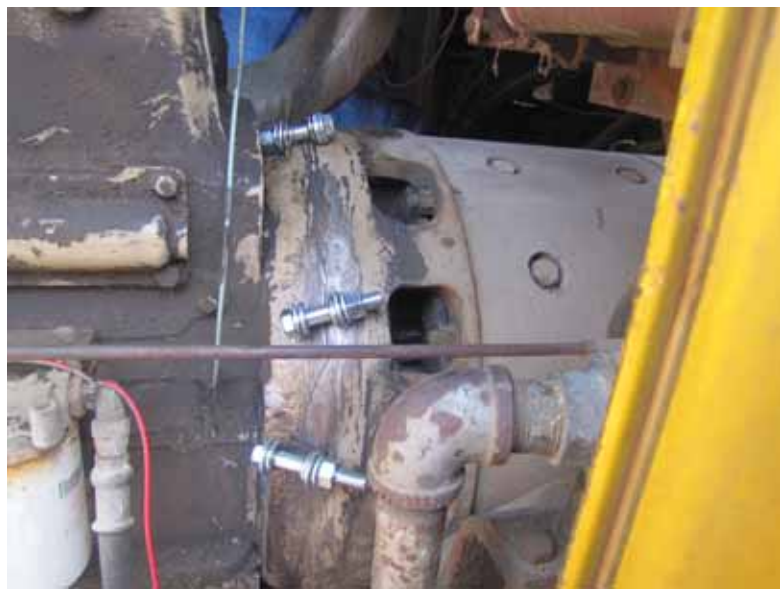
We are finally done and we feel the bolts will hold the bell housing securely.

Our next step is to repeat the process on the left side of the engine. Because the crack is longer, we will install 3 sets of eyebolts and 1/2 inch bolts.

Jim brought some high speed metal only drills. That along with using a powered drill made the drilling go faster. The tapping took longer because of the limited access and interference from other parts of the diesel.

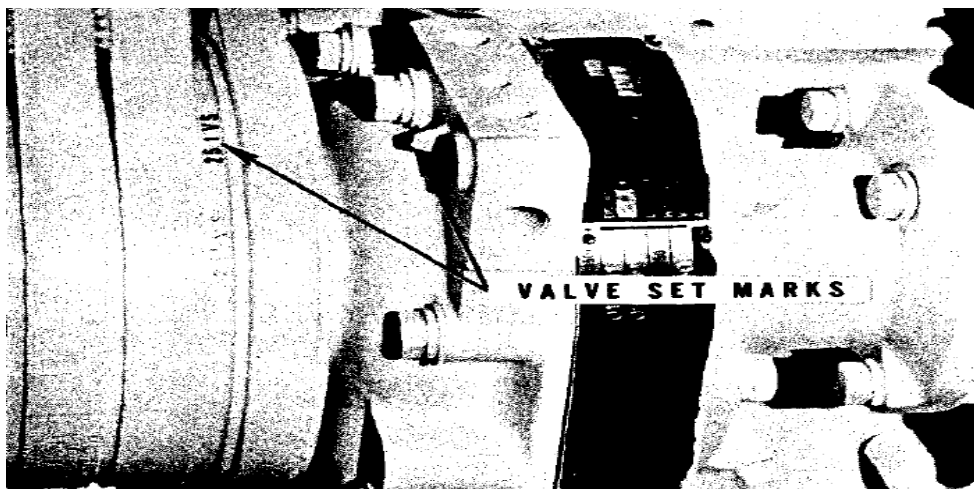
In the meantime, we had to look for the timing marks on the engine to set the injectors. According to the picture it was supposed to be on a pulley between two of the sheaves. Well after much looking and wire brushing, we found the mark! It was stamped into the edge of the first pulley instead of where the picture shows it. That was only half the battle, however because we had to find the corresponding set mark on the flange. Well instead of it being a pointer, it was a stamp like a maple leaf!

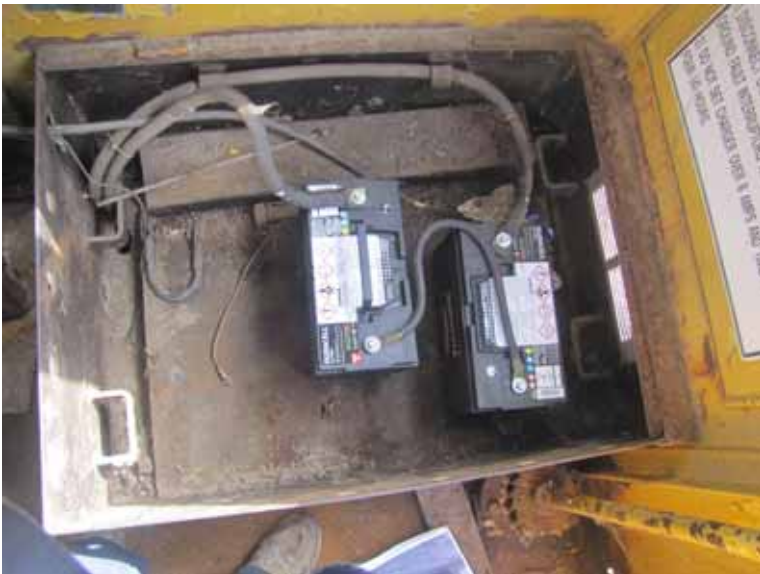
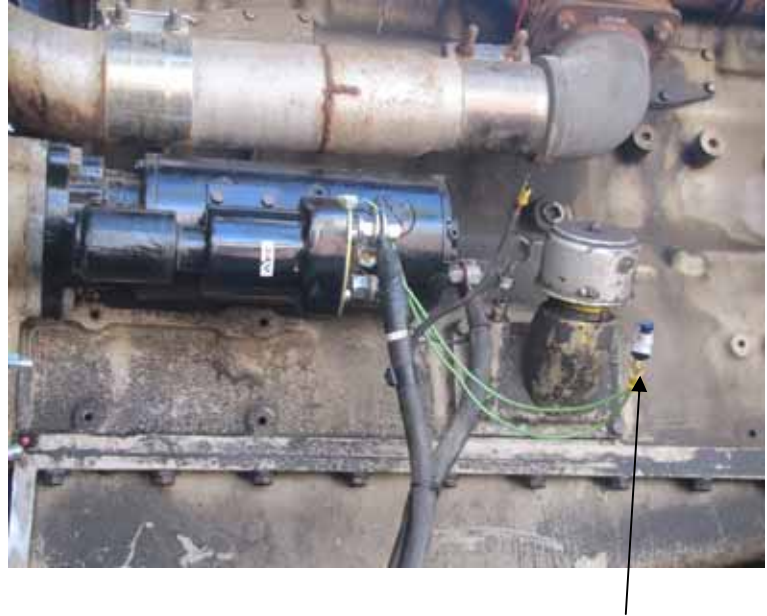
PUSHBUTTON

We also bought a push button switch to energize the starter when we are ready. It will give more control than just touching 2 wires together.

We installed the batteries and the starter. We also connected the pushbutton to the starter solenoid. We pushed the button, and the engine turned over easily! SUCCESS!

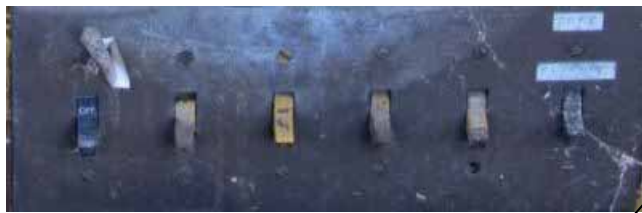
## SWITCH PANEL

In anticipation of getting the engine running, we researched the original wiring diagram, which bears some resemblance to the way the engine is wired now. There is a series of toggle switches on the panel that are unmarked. In looking at the panel of a similar engine, we have figured out what the switch functions are. The first effort was to locate the Control Switch, which supplies power to the relays controlling the direction of the engine.

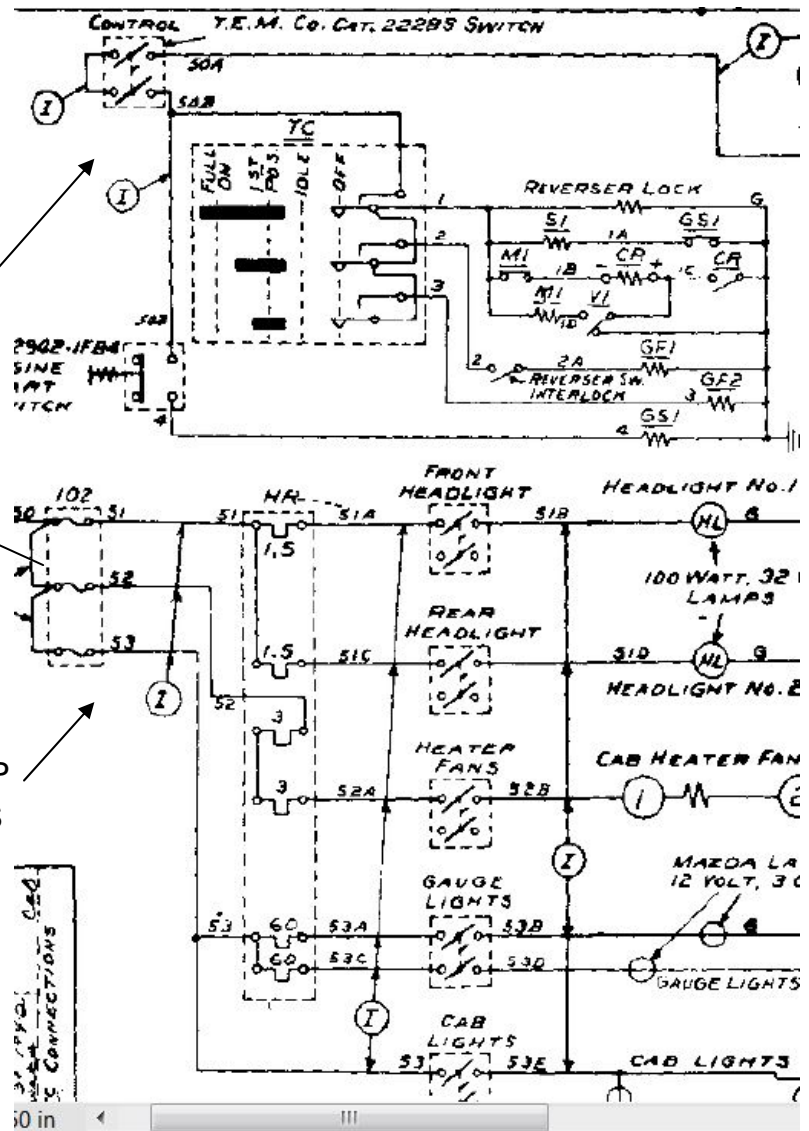
10 AMP  
FUSES

In further anticipation of getting the engine running, I went out to the electrical cabinet to check some voltages. When I threw the main switch, the voltmeter on the panel read 24 volts, which is what it should have read. I then proceeded to check the voltage on all 6 fuses, and they all read 24 volts. That is a good sign that this part of the wiring matches the diagram in the 1941 manual.
